# NAVAL SUBMARINE BASE KINGS BAY FLEET MOORINGS UNDERWATER INSPECTION REPORT

MAY 1985

OCEAN ENGINEERING  
AND CONSTRUCTION PROJECT OFFICE  
CHESAPEAKE DIVISION  
NAVAL FACILITIES ENGINEERING  
COMMAND  
WASHINGTON, D.C. 20374

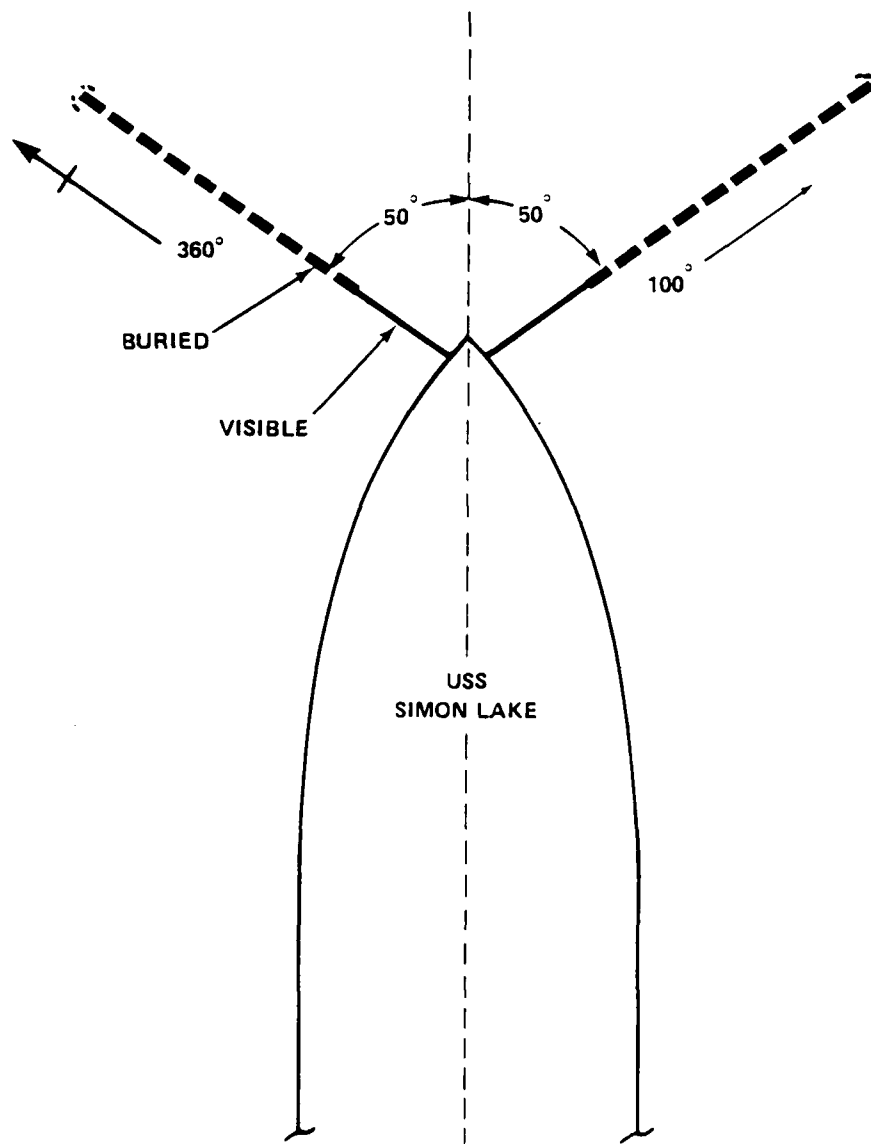
Figure A-1. USS SIMON LAKE Bow Legs

Bow Anchor Chain Subassemblies. The two legs consist of 3 1/2-inch Dilok chain. All double-link measurements of these legs indicated over 90 percent of the original wire diameter. The port leg bears approximately 360 degrees magnetic from the bow of the ship, and the starboard leg bears approximately 100 degrees (see Figure A-1). Both legs are under tension. Inclinator readings were recorded on each leg as shown below.

Buoys. Each of the two bow legs has a 9 1/2-foot-diameter drum-type buoy with a tension bar. Each buoy has approximately 37 inches of freeboard, moderate rust and peeling paint, and 2 inches of marine growth on its bottom. Each has two rubber fenders and chafing rails.

The retriever buoys are connected to the bow leg chains by 1 3/4-inch chain. Measurements of this chain near the mudline were between 80 and 90 percent of

their original wire diameter. Although design drawings indicate that the 1 3/4-inch chain is attached to the bow leg chains at the first sinker, this could not be verified since the leg chain and sinker were both buried in the mud.

- o Overall, the Mediterranean mooring is in good condition and satisfactory for continued fleet use.
- o Due to measurements between 80 and 90 percent near the mudline, the retriever buoy chain should be refurbished during the next scheduled mooring overhaul.
- o In its current configuration, the northern stern leg contains 12 consecutive detachable links. During the next scheduled overhaul, this unusual and nonstandard configuration should be replaced with a comparable length of 3 1/2-inch common "A" links.

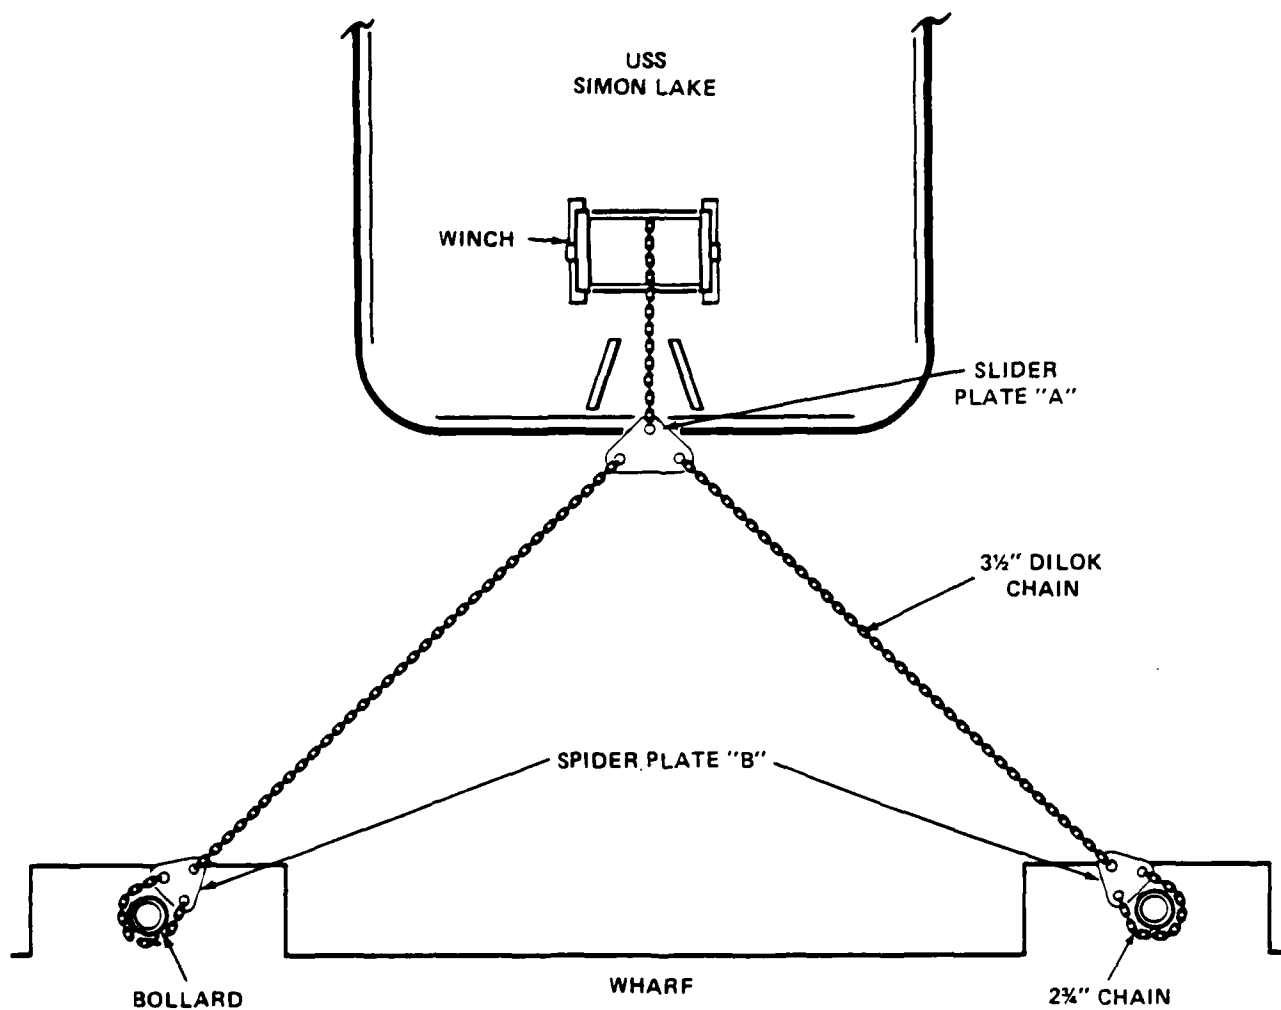
Figure A-2. USS SIMON LAKE (AS 33) Stern Legs

Stern Legs. Two 3 1/2-inch Dilok chain legs secure the stern of the Tender to the eastern end of the wharf at SUBASE Kings Bay. Both legs are rusting and the paint on them is blistering. Double- and single-link measurements were all above 90 percent of the original wire diameter. A schematic diagram of the Mediterranean mooring's stern legs is contained in Figure A-2.

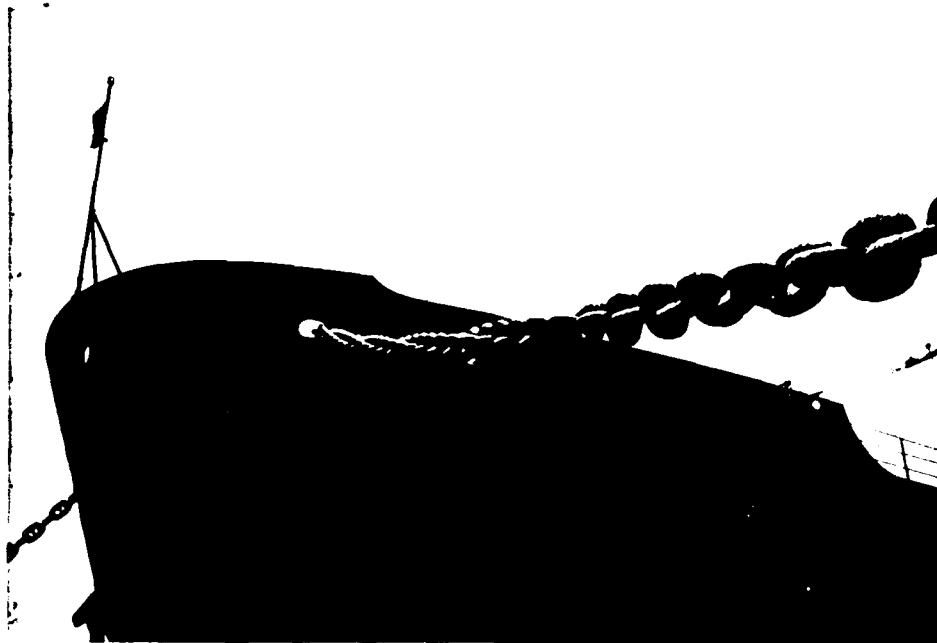
Mediterranean Mooring Bow Legs - Note Twisting.

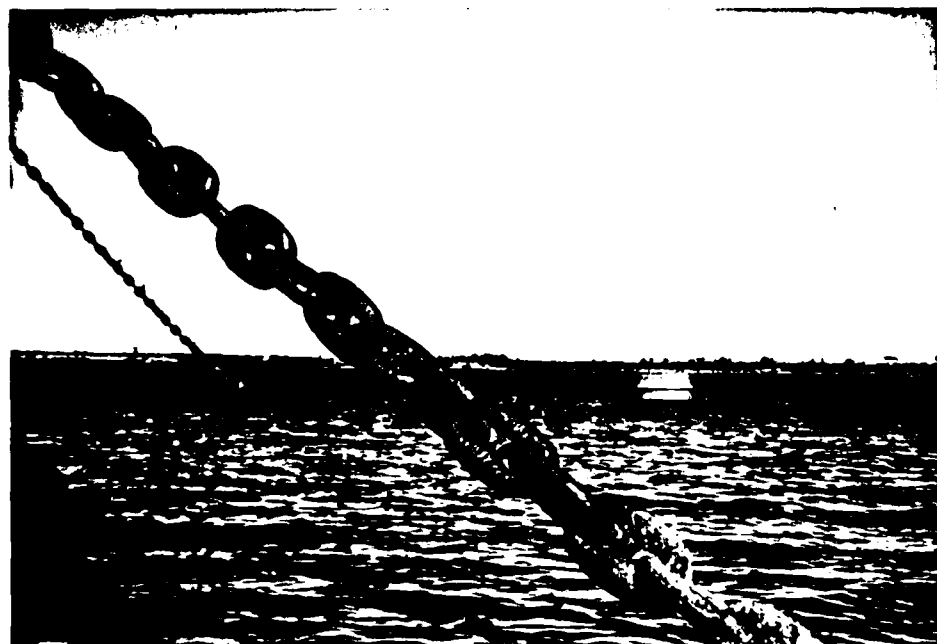
Mediterranean Mooring - Note The Configuration  
Of The Bow Legs And Condition Of The Chain.
